**SITE 004 TRACK 1
DECISION DOCUMENTATION
PACKAGE, OU 10-08**

**DECISION DOCUMENTATION PACKAGE
COVER SHEET**

Site Description: Diesel-Saturated Dirt Pile Near Experimental Field Station

Site ID: 004

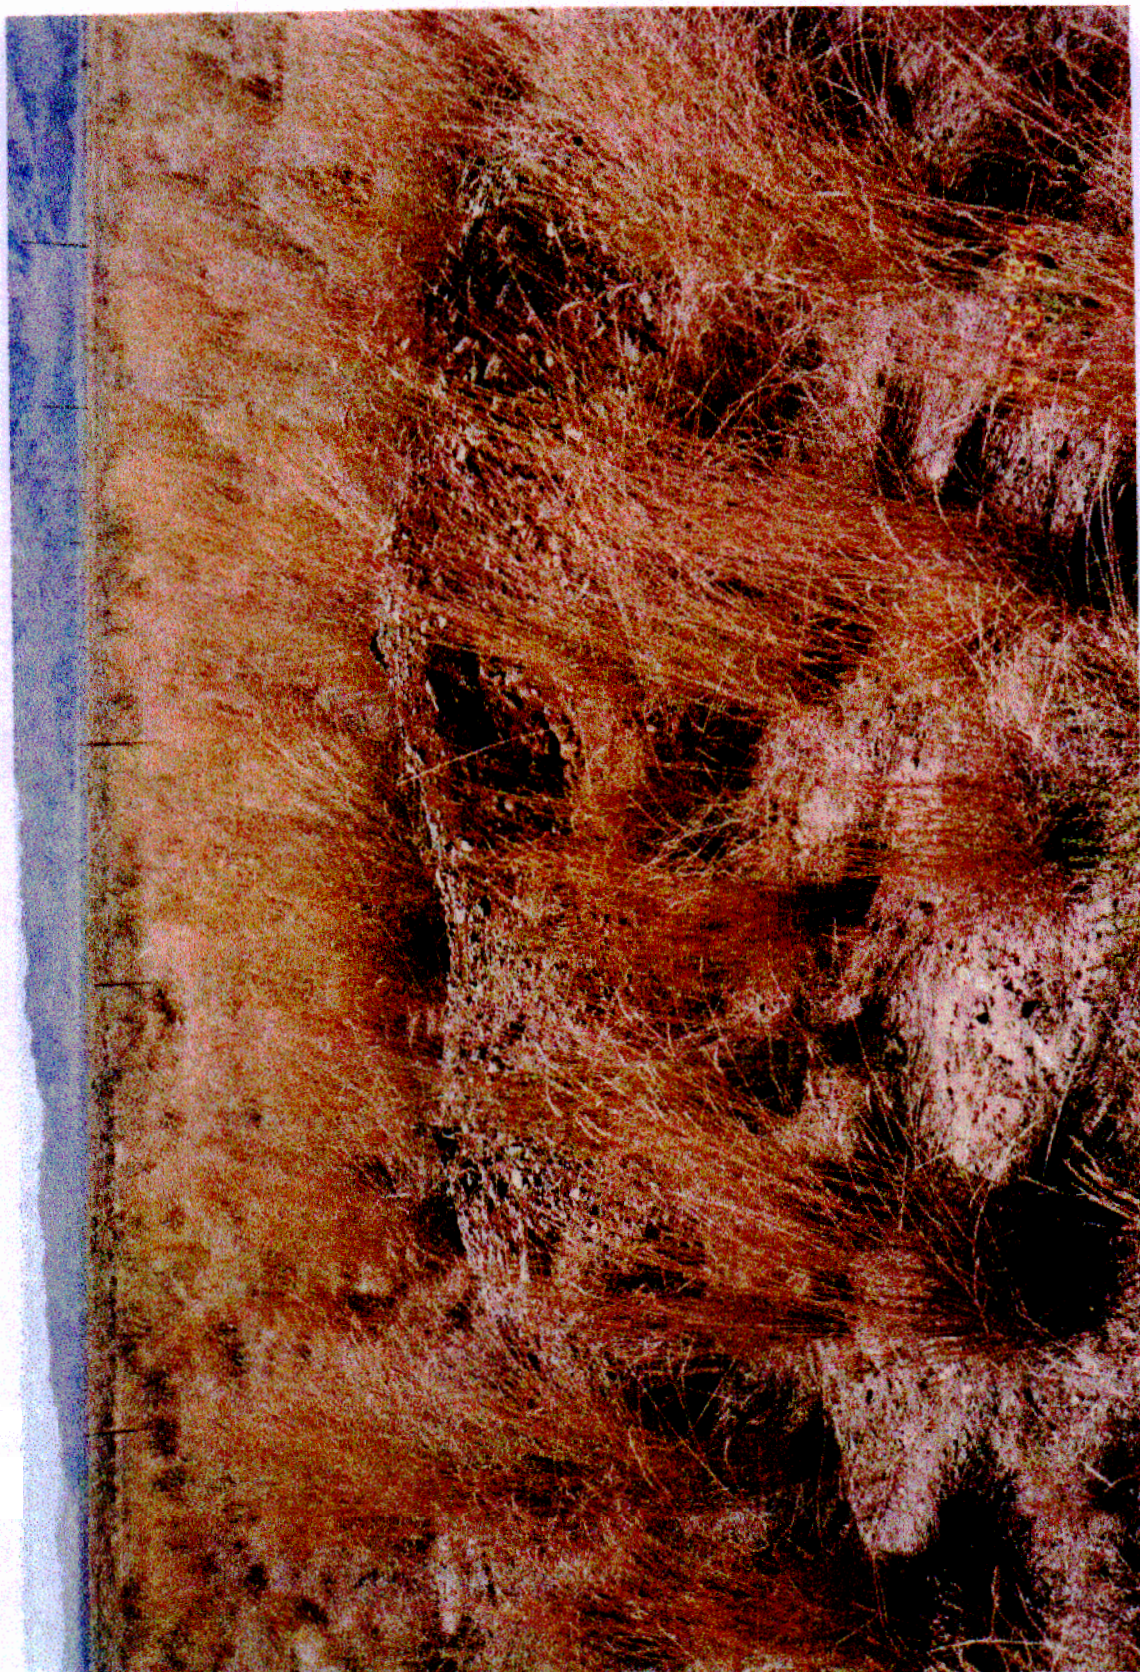
Photograph of Site #004

Site: 004 Diesel-saturated Dirt Pile Near Experimental Field Station
(PN94-0856-1-32A)

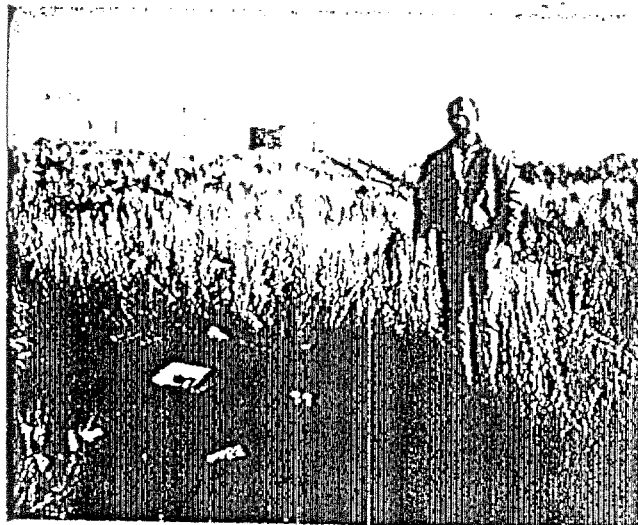
Site # 2, sample location

10845 - Arrive at site #2. Hold prejob, don PPE. The material is black, sandy, almost basaltic grit, fairly loose in top 1/8" but quite hard just under 1/8". A representative area was selected in the center of the ~9 x 12' area. The material also has a "crystal" look. This site only requires analysis for total metals per requester. There appears to be some small yellow points on the grit. The hardness below 1/8" is due to the weather, as far as we can tell. A stainless steel spoon is used to collect and composite material. After 4" adequate volume has been attained, so samples are collected after mixing. Bottom depth of material was not determined, but we sample from the expected high point. Go to 195.
